Methamphetamine FC Screening Assessment Report

Address inspected: 30 Simon Owen Place, Golflands, Auckland

Date of Inspection: 11/11/2020 Time: 11:00am

Test type: Field Composite (FC) Swab Screening Test - no. of sample kits = ONE				
Conclusion: Screening result was negative for methamphetamine, indicating that no further testing is necessary. PROPERTY MEETS NZ STANDARDS - NO METH DETECTED.				
Property description: 2 story residential house, internal garage.				
Sample Kit 1	Location	Photo	Result	
1 House & garage	All rooms sampled.	Yes	NEGATIVE μ g Field Composite Screening tests combine the level of the rooms tested.	
2				
3	See pics for exact locations.			
4	Total locations swabbed = 16	Yes

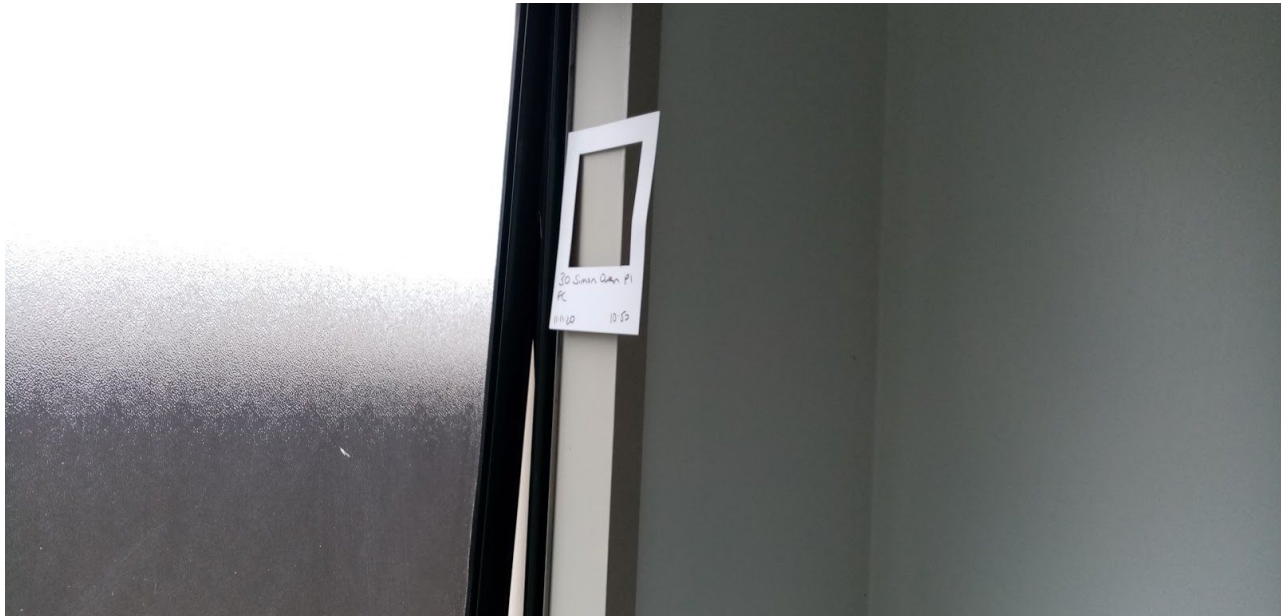
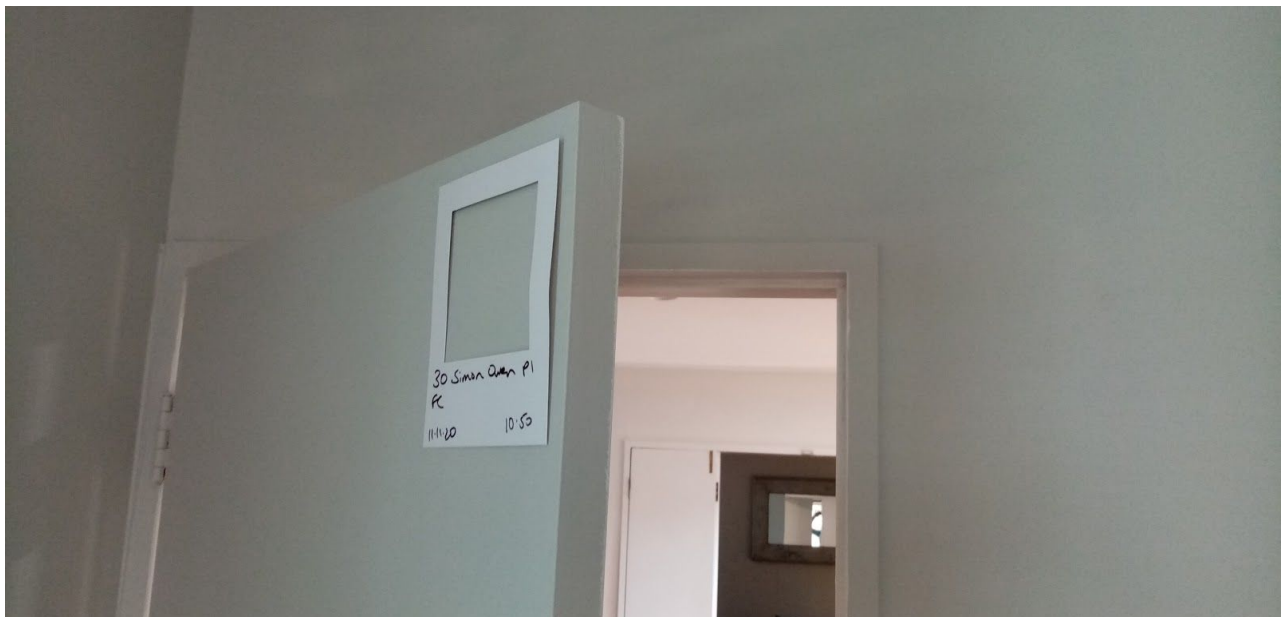
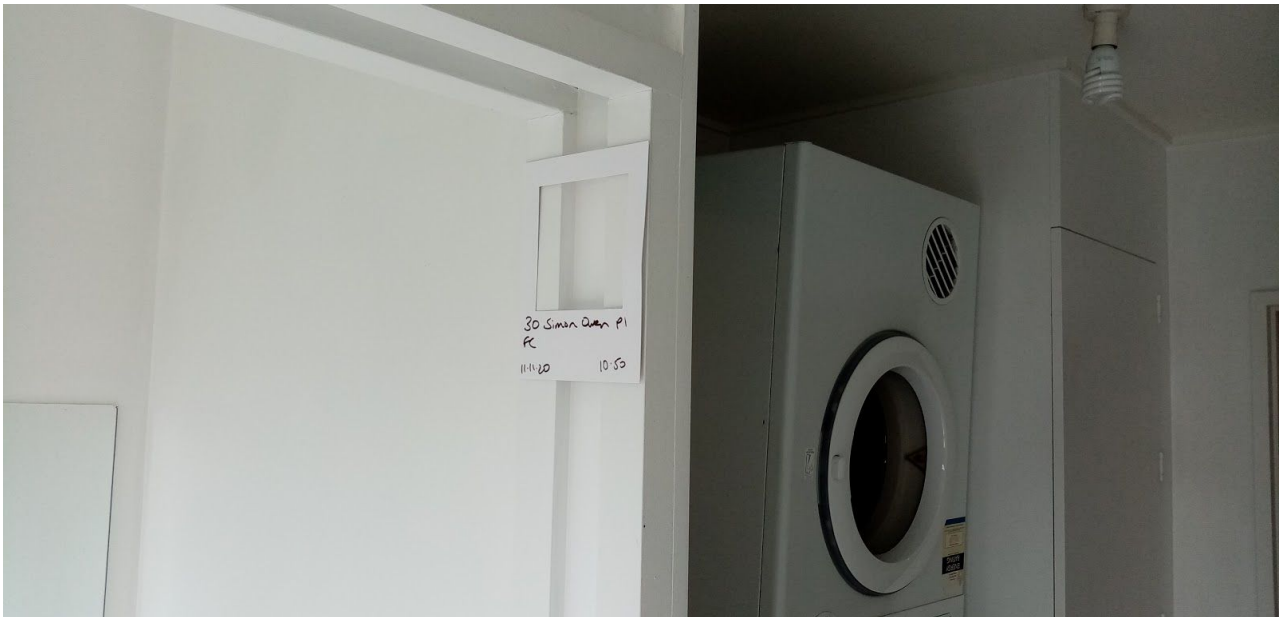
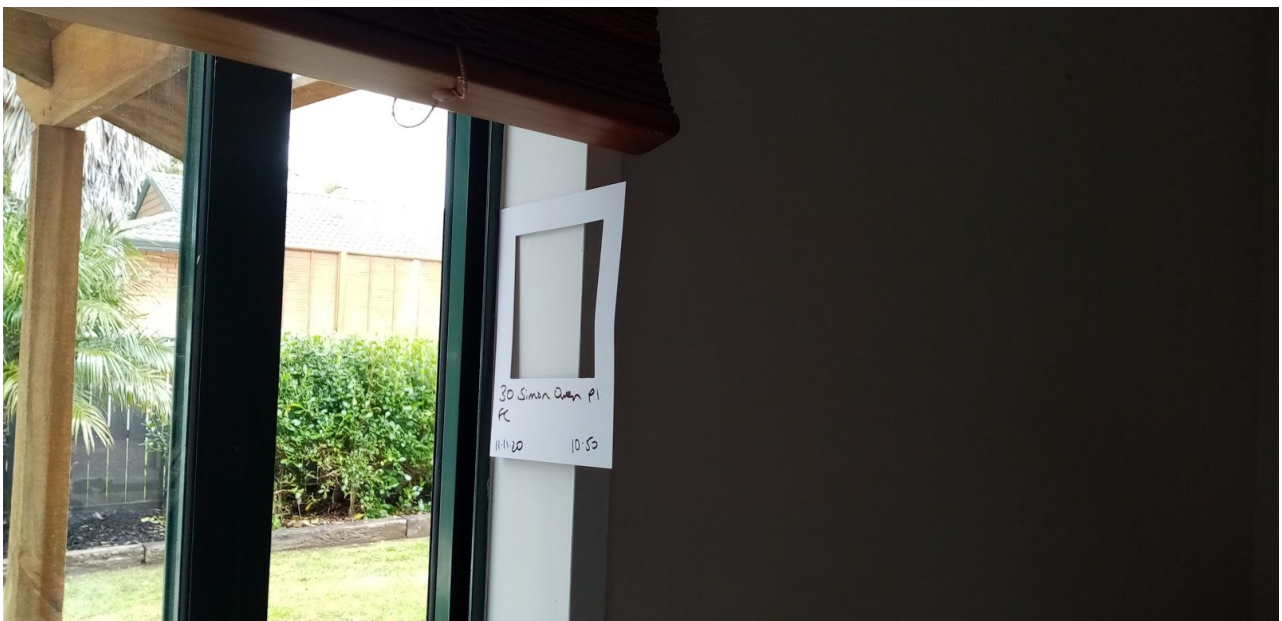
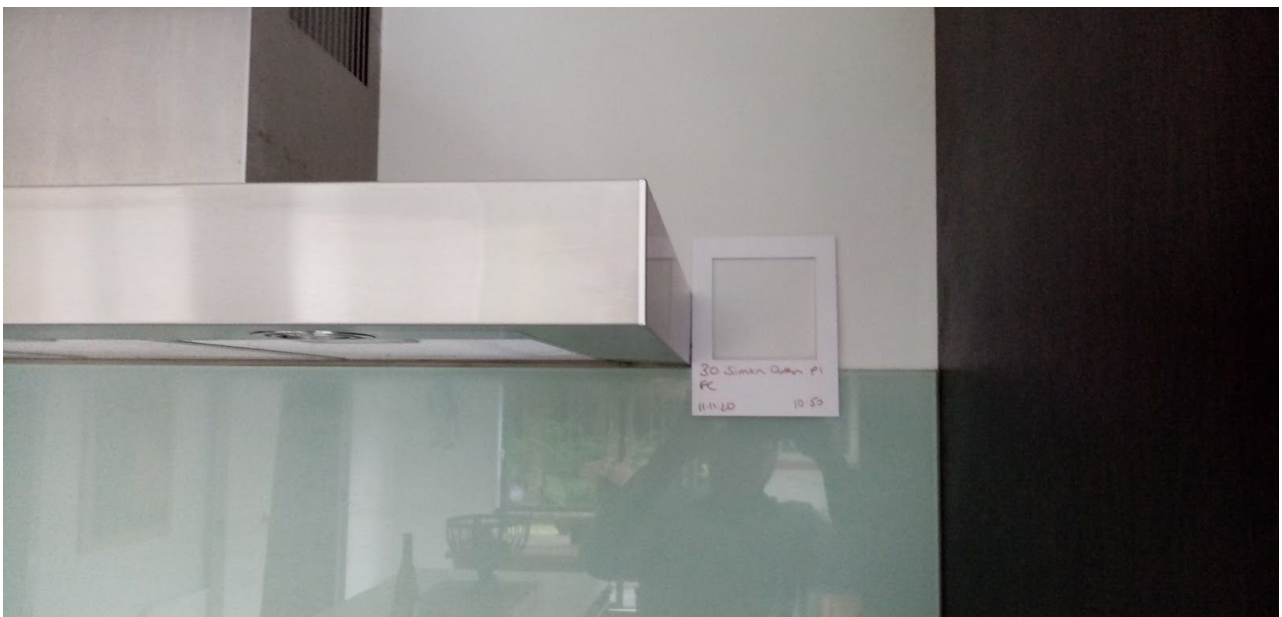
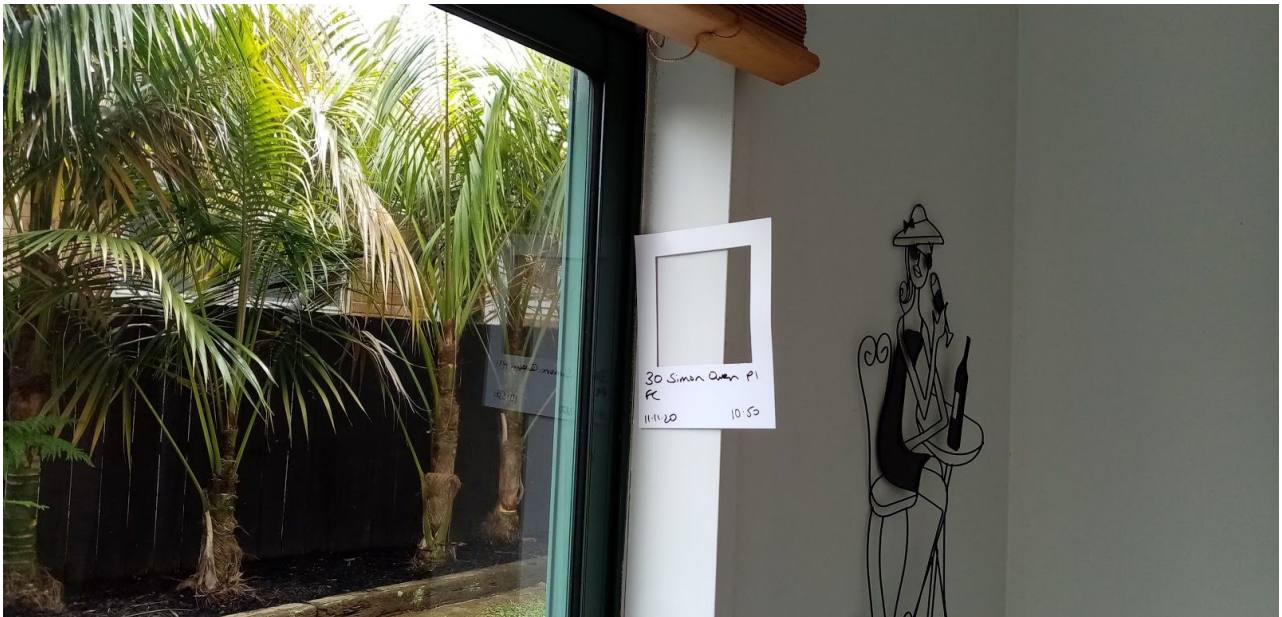
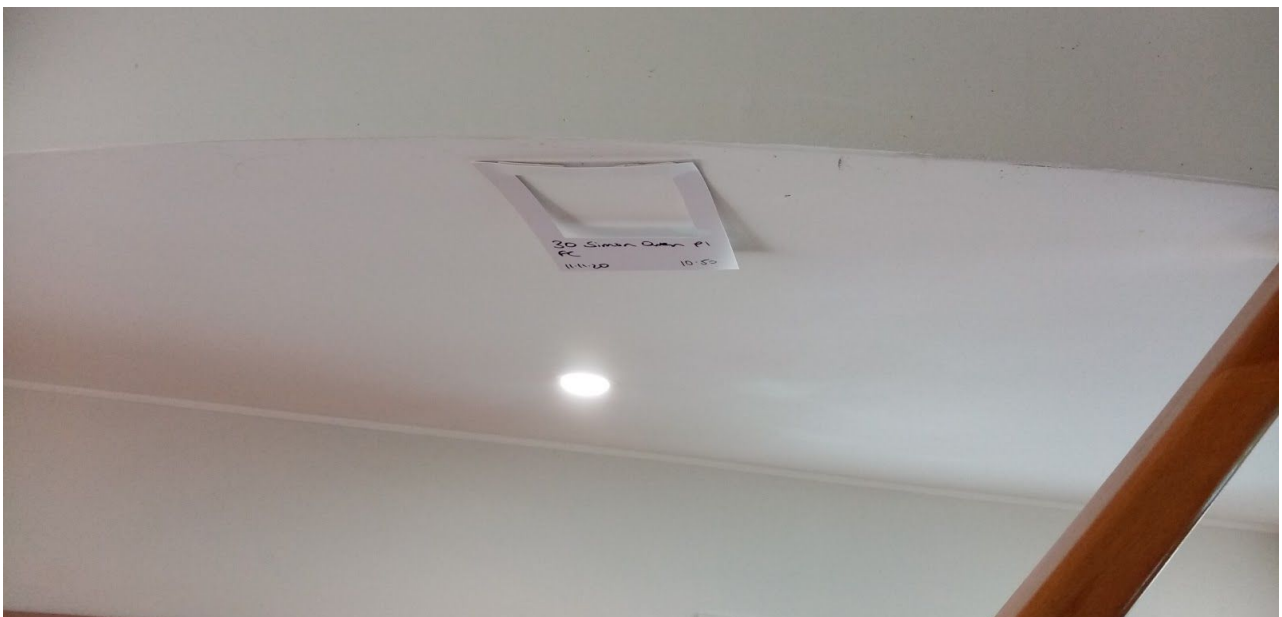
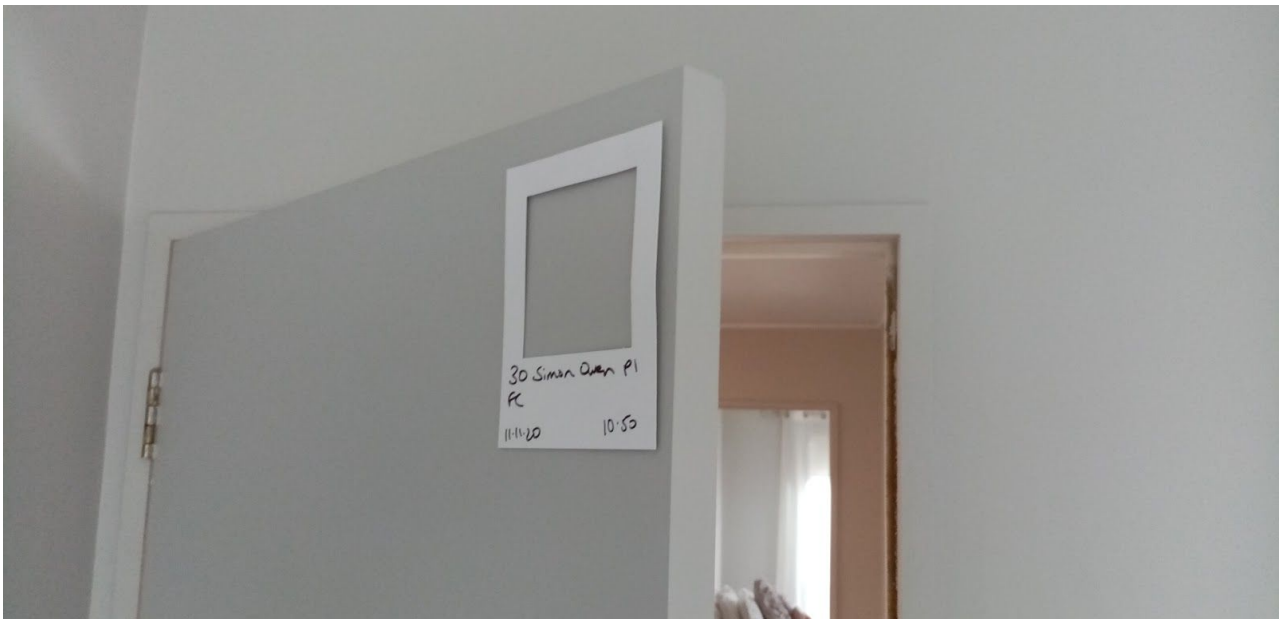
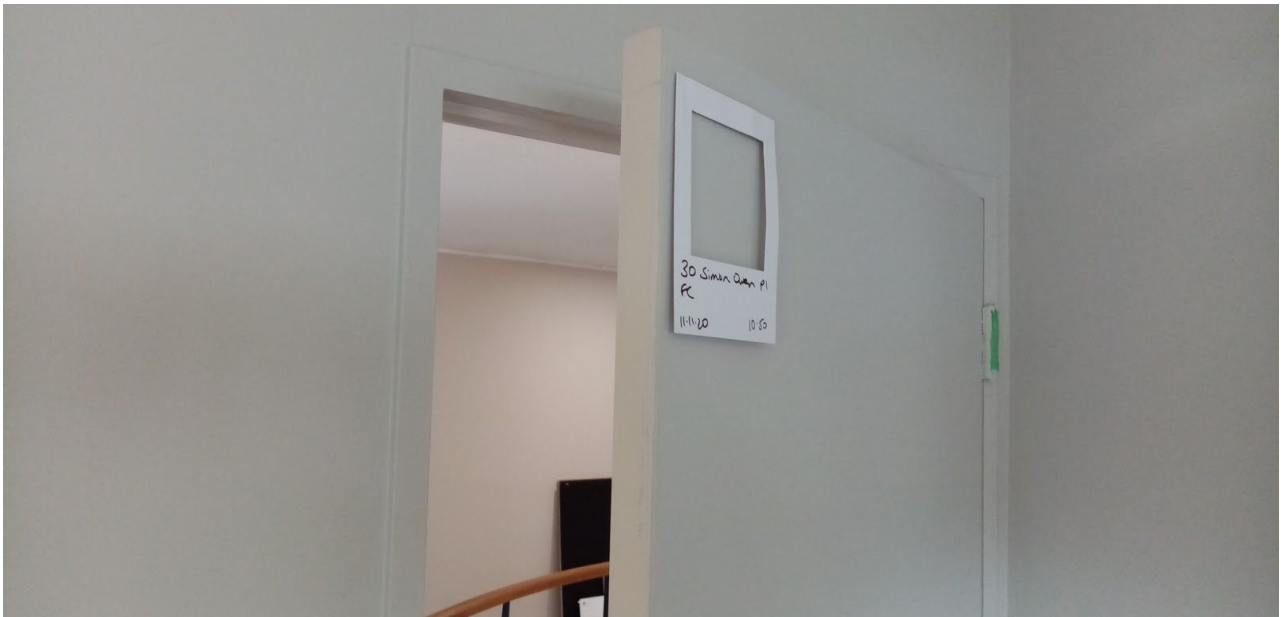
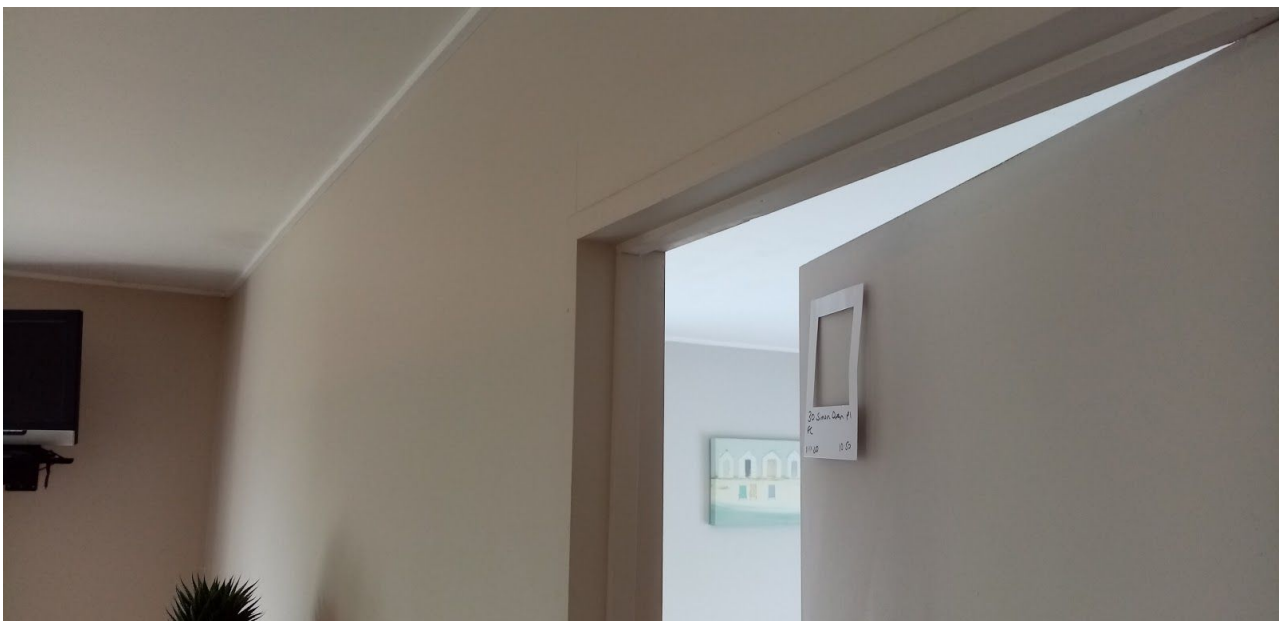
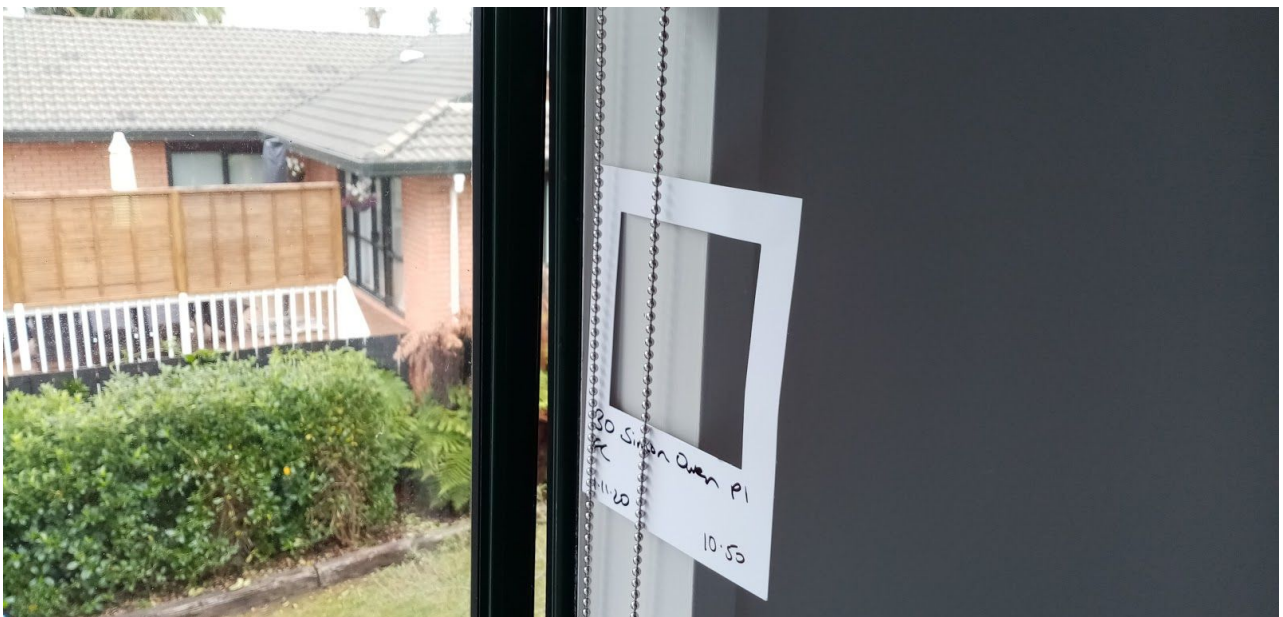
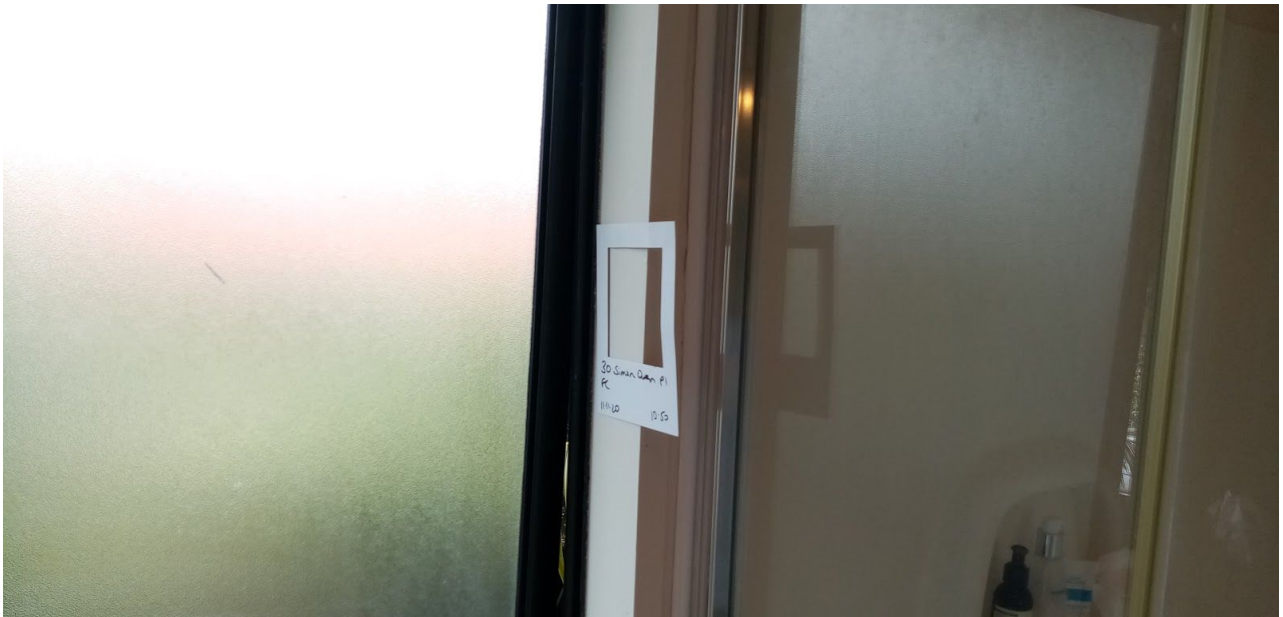
Pictures are for reference if further testing or other evaluation needed.

Photos and samples usually taken in a clockwise direction around house, starting in kitchen.

All rooms tested within the property were **negative** or below any health risk guidelines for methamphetamine indicating that no further testing is necessary.

Samples were collected in **all** rooms.
